CASE STUDIES ON THE EXPLOSION OF ORGANIC POWDERS IN THE PHARMACEUTICAL INDUSTRY AND IN THE FOUNDRY SAND

The two case histories illustrated in this paper concern (a) the formation of dust clouds, with particular attention paid to the role of fine powder fractions, and (b) the evaluation of ignition energies and corresponding powder characterization. It is believed, or at least hoped, that such studies could stimulate the development of improved containers and associated safety equipment design.

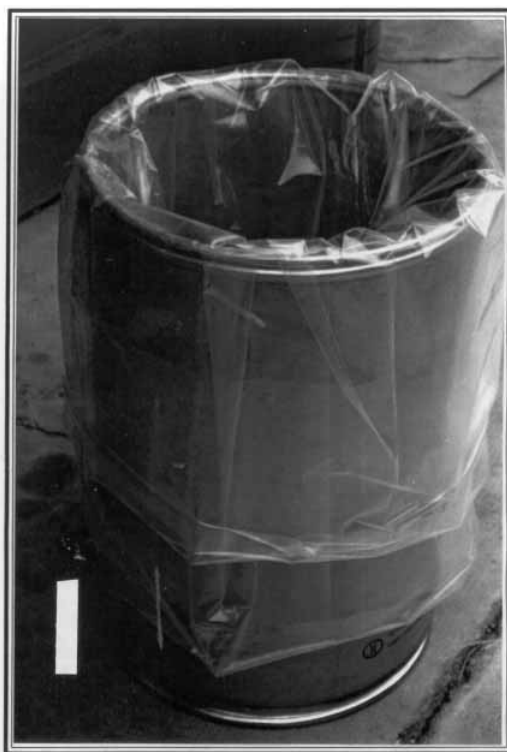
¹ Each production batch began with loading the powdered organic substance contained in four fiber drums through the hatch of a previously emptied 3,000 L reactor. The explosion occurred when the two workers involved in the operation were just finishing loading the second drum, i.e., after 2÷3 minutes.

Fig. 1 - Fiber drum.

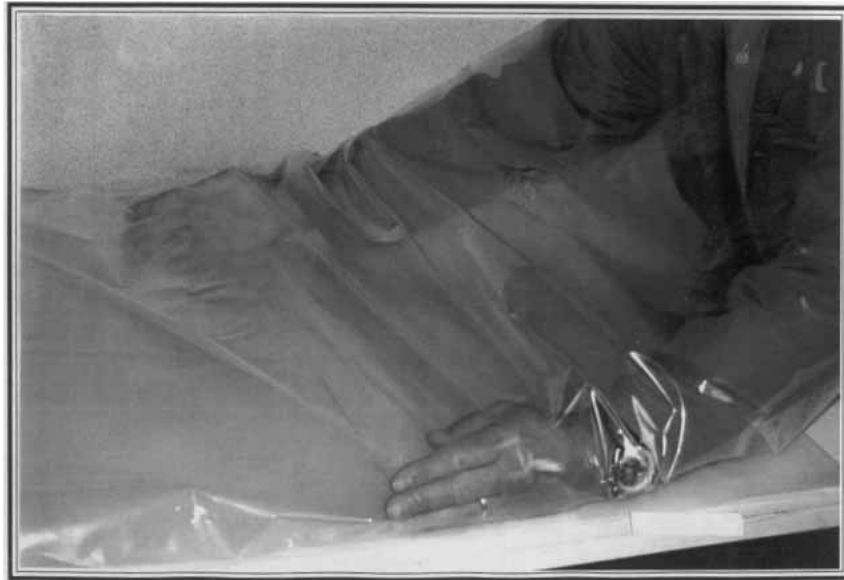
Fig. 2 - Surface voltage test

Tests were made by simply opening the bags and rubbing them inside in order to separate the two sheets (Figure 3). All bags got charged, whatever their antistatic additive content. However, the electrostatic charge disappeared instantaneously from the bags that were truly antistatic. On the contrary, the charge remained on the plastic sheet for a long time, sometimes hours and days, when the bags were not antistatic⁵. It should be remarked that few of them showed this behaviour. The results of the tests were the following:

- the value of the electrostatic potential found on the plastic sheets that were not antistatic varied between +3 and + 16 kV, often reaching values greater than +20 kV;
- an estimate of the ignition energy was obtained through the relation $E = \frac{1}{2} CV^2$, which gives the amount of energy E (mJ) that can be obtained from a body having capacity C (picofarads) brought to a potential V (kV). In the case of a plastic bag the capacity can be estimated as being equal to 100 pF. The surface energy thus varied from 20 to 50 mJ.

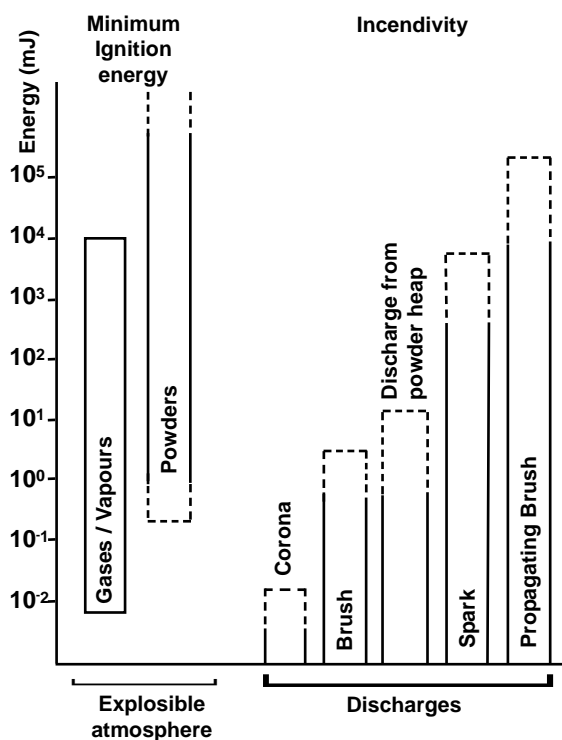
Fig. 3 - Ignition energy

It can be noticed that the energy obtainable from the plastic sheet had about the same value as the energy required to ignite a dust cloud (5). In connection to this, the 'powders' and 'spark' segments in Figure 4, taken from M. Glor (ref 7), should also be examined. Antistatic bags showed energy values of the order of 1 mJ (1÷5 kV), too small to ignite the substance. It should also be recalled that the dielectric constant of air would prevent the electrostatic discharge with surface voltage values lower than 5 kV.

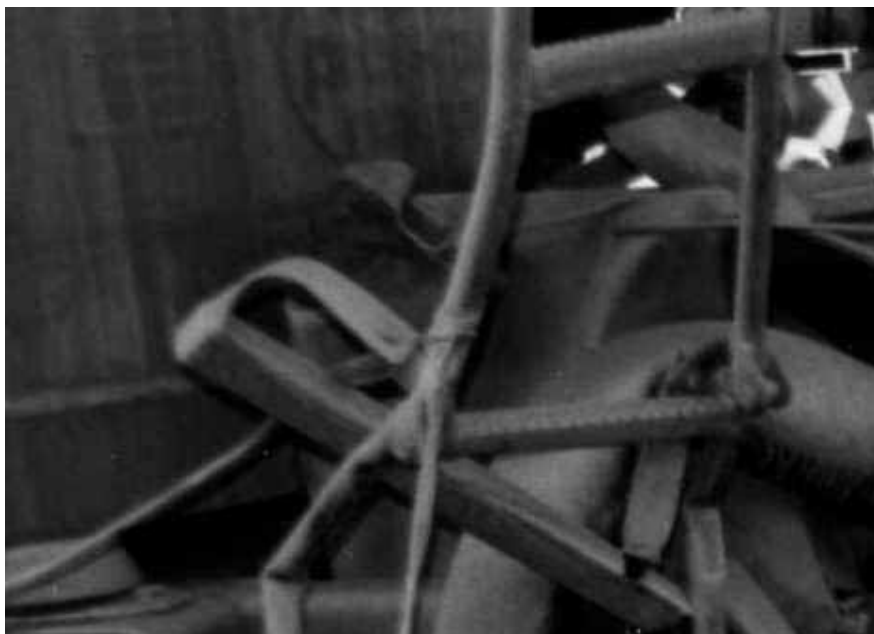
Fig. 4 - Fragments of the tank.

The explosion took place while foundry sand was being pneumatically discharged to a cement works silo. The accident caused the front tank to break into various parts (Figure 4) - one of these parts being roughly cut along the plane passing through the symmetry axis - and substantial deformation of the upper part of the back tank in proximity to the front tank (Figure 5). The fragments of the tank were hurled in all directions, some of these fragments hitting the driver who sustained serious injuries all over his body.

as is customary, once the discharge operation was almost over, the driver closed and re-opened the discharge valve both to cause said particles, no longer sustained by the gas flow, to fall and to then drive them towards the exit gate; this specific operation led to the formation of mechanical sparks resulting from the friction of the ferrous materials on the bottom of the tank (the generation of electrostatic charges was ruled out as foundry sand is almost conductive, given the relatively slow value of electric resistivity); the spark triggered the ignition of the flammable dust cloud, which - being at the maximum pressure of 1 bar, could lead to an explosion pressure value of 1.6÷2 MPa, given an explosion pressure value of 0.8÷1 MPa for

dusts under standard conditions;
given a pressure excess of 1.7÷2.1 MPa , the tank membranes ruptured;
the pressure generated found an outlet through the spaces in between the
fragments that were hurled in all directions and the resulting turbulence
dragged other dust; this fuelled the combustion (flame-thrower effect)
which hit the driver engaged in the discharge operations.

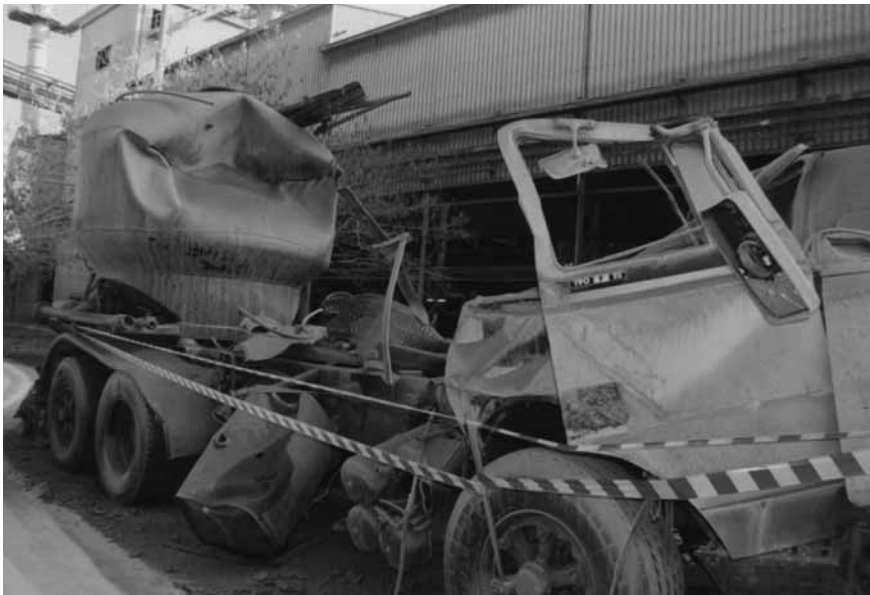
Fig. 5 - Deformations of the truck
